FIELD STUDY OF FENCING MATERIALS IN A MARINE-ATMOSPHERIC ENVIRONMENT -
RESULTS OF UP TO THREE YEARS OF ATMOSPHERIC EXPOSURE AND CORROSION RATE
DETERMINATION

Technical Note N-123

Eddy S. Matsui

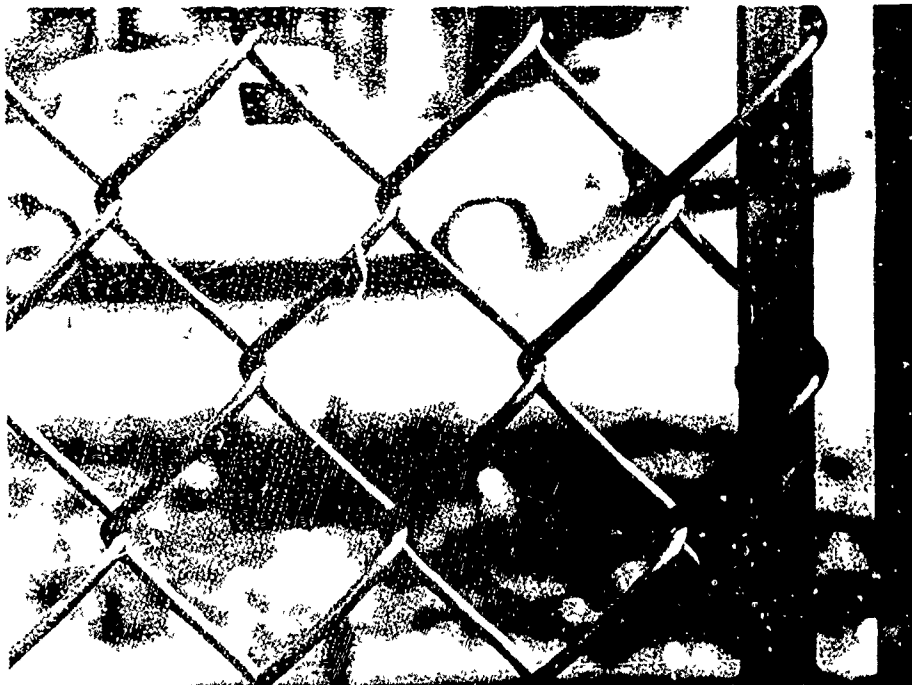
Figure 8. System 5. Newly installed vinyl-clad galvanized steel.

Systems 5 and 6 - Vinyl-clad Galvanized Steel Fabric: After the 3 years of exposure there was no evidence of cracking, color-fading, or any other visible form of deterioration in the polyvinyl chloride covering. Accumulations of air-borne sand and dirt on the wires were quickly washed away after each rainfall and the appearance of the fabric was as good as when installed (Figures 8 & 9). The white corrosion product observed at the cut-end is considered normal for this type of fencing and it did not corrode any further nor cause any rust stains.

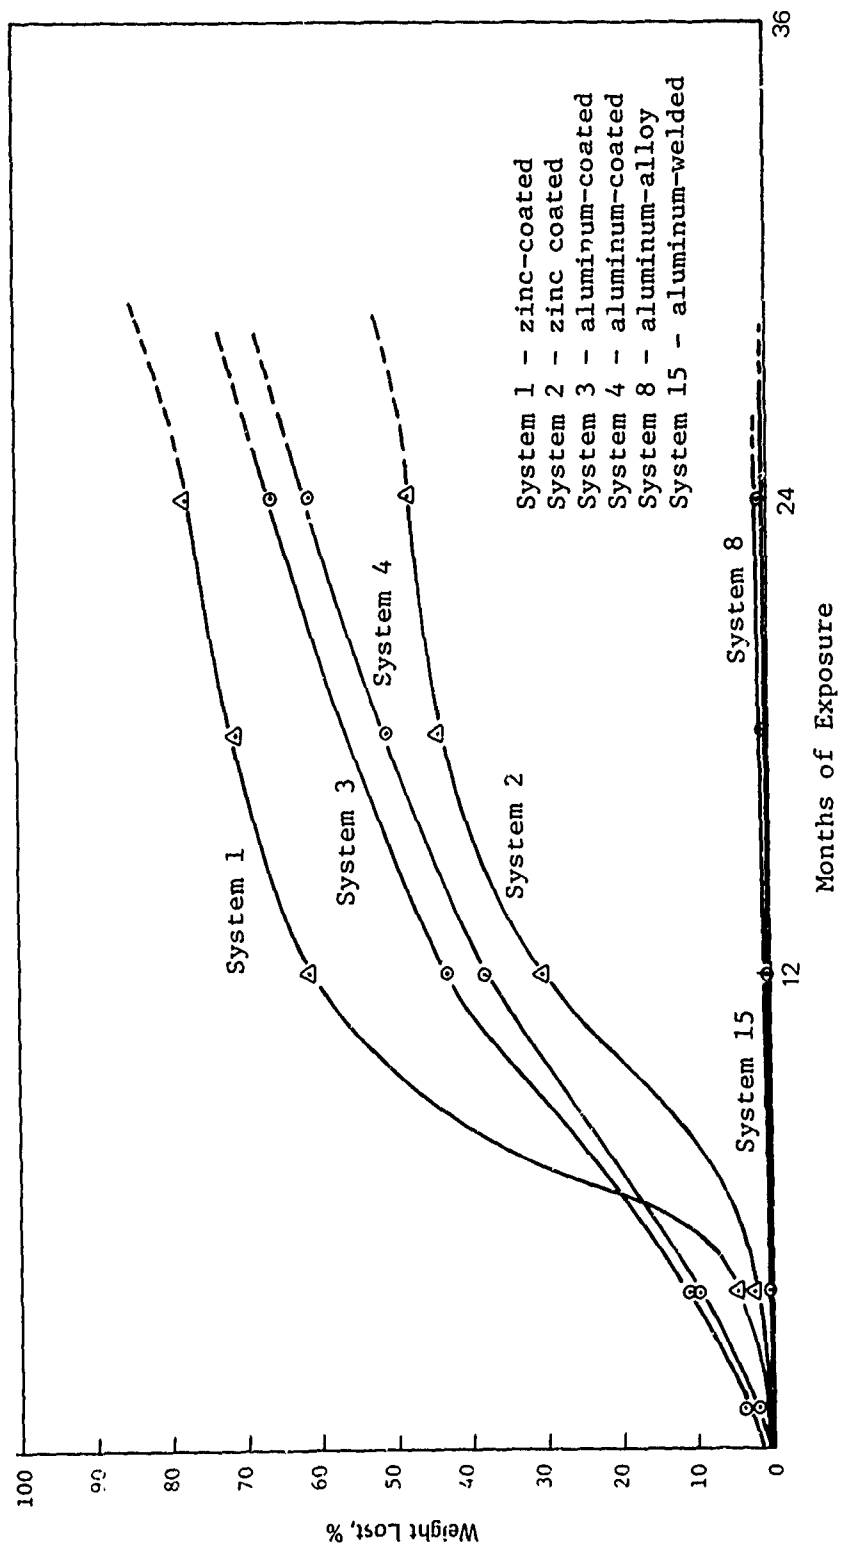
Figure 27. Corrosion patterns of metal-coated and alloy fence wires in marine atmospheric environment.

A graphical illustration of the corrosion attack on metal-coated and alloy wires in the atmospheric environment is shown in Figure 27. During the initial four months, the graph shows that the wires lost their zinc coating slowly, and during the next few months, they lost the coating very rapidly. After 12 months of exposure, the corrosion rate of the zinc coating decreased with time.

The graph in Figure 27 shows that the wires of Systems 3 and 4 steadily lost their aluminum coating.

Stainless Steel Wire, System 9: During the 24 months of exposure air-borne sand and dirt accumulated on the stainless steel wire and gave it a rusty appearance. However, the sand and dirt were easily wiped off and the wire revealed a metallic appearance underneath. The wires demonstrated no other sign of corrosion (Figure 32). The corrosion rate was very small as shown in Table 5, and it could not be illustrated graphically in Figure 27.

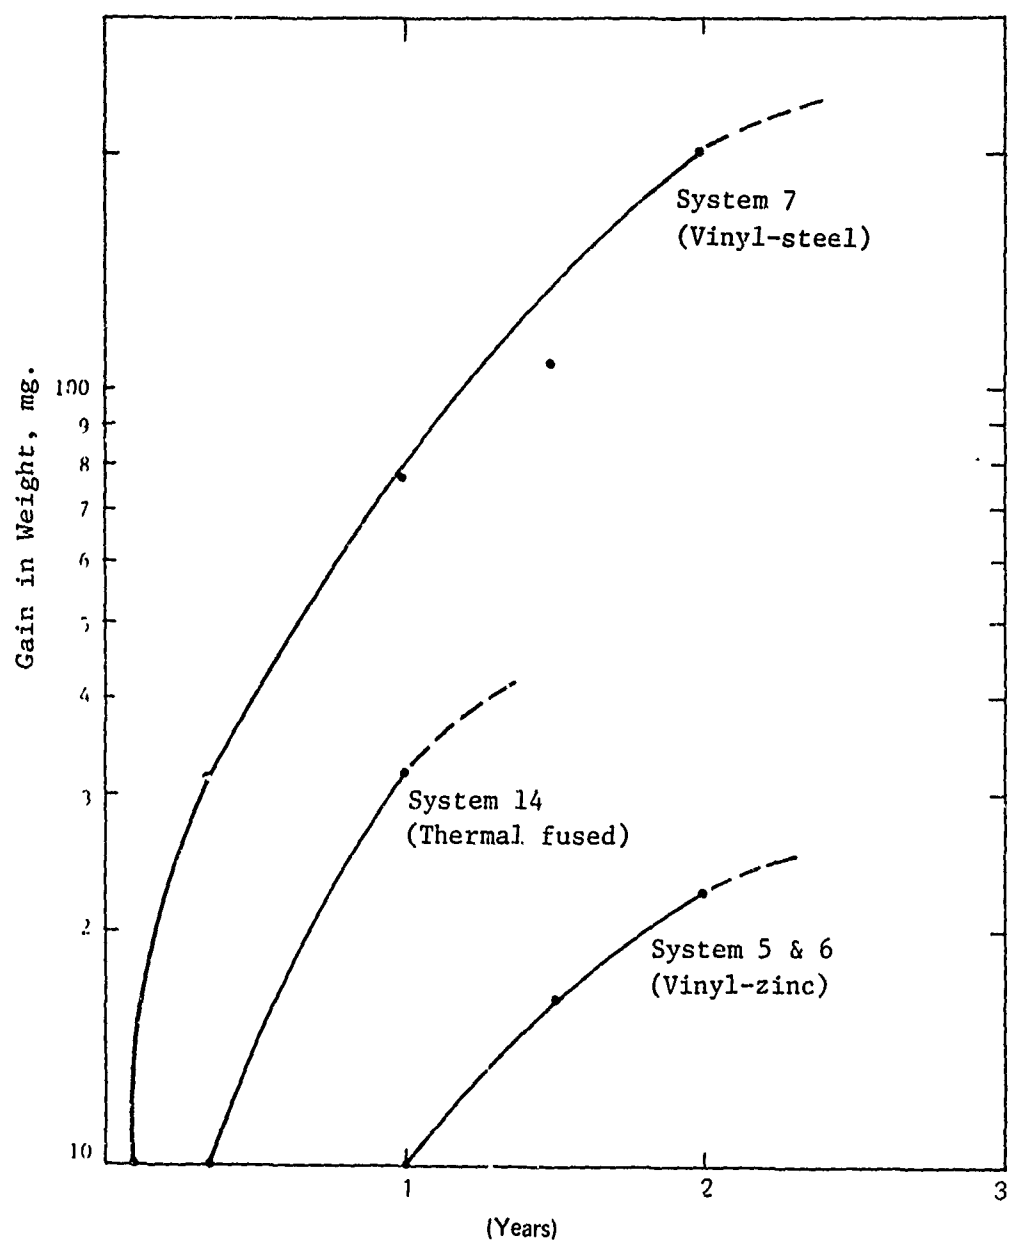
Figure 33. Corrosion patterns of vinyl-coated fence wires in atmosphere.

The corrosion rate of the vinyl-coated wires was determined by the weight gain method as described in an earlier section of the report. The results are listed in Table 6. A graphical illustration of the corrosion rate of vinyl-coated wires during the 24 months of atmospheric exposure is shown in Figure 33. Although visual inspection of the test fence did not reveal the condition of core wire, the graph shows that System 5 is the most corrosion-resistant system compared to Systems 7 and 14. System 7 appeared to be corroding faster than the other two systems. System 5 gained 7.1 mg while Systems 7 and 14 gained 76.2 and 31.6 mg of the corrosion product, respectively, during the 12 months of exposure. There was no apparent red-rust accumulation in the inter-space between the vinyl-coating and the core wire of System 5, except for the white corrosion product found near the cut end and scribed area, when the underlying core wire was examined after removing the vinyl coating (Figure 34). Most of the core wires of Systems 7 and 14 were also well protected from corrosion and maintained the original metallic appearance, except near the cut-ends and scribed areas (Figures 28 and 34).
